ELECTROLYSIS¹

¹ A discussion of an informal address by Prof. Albert F. Ganz before the New York Section on December 20, 1916.

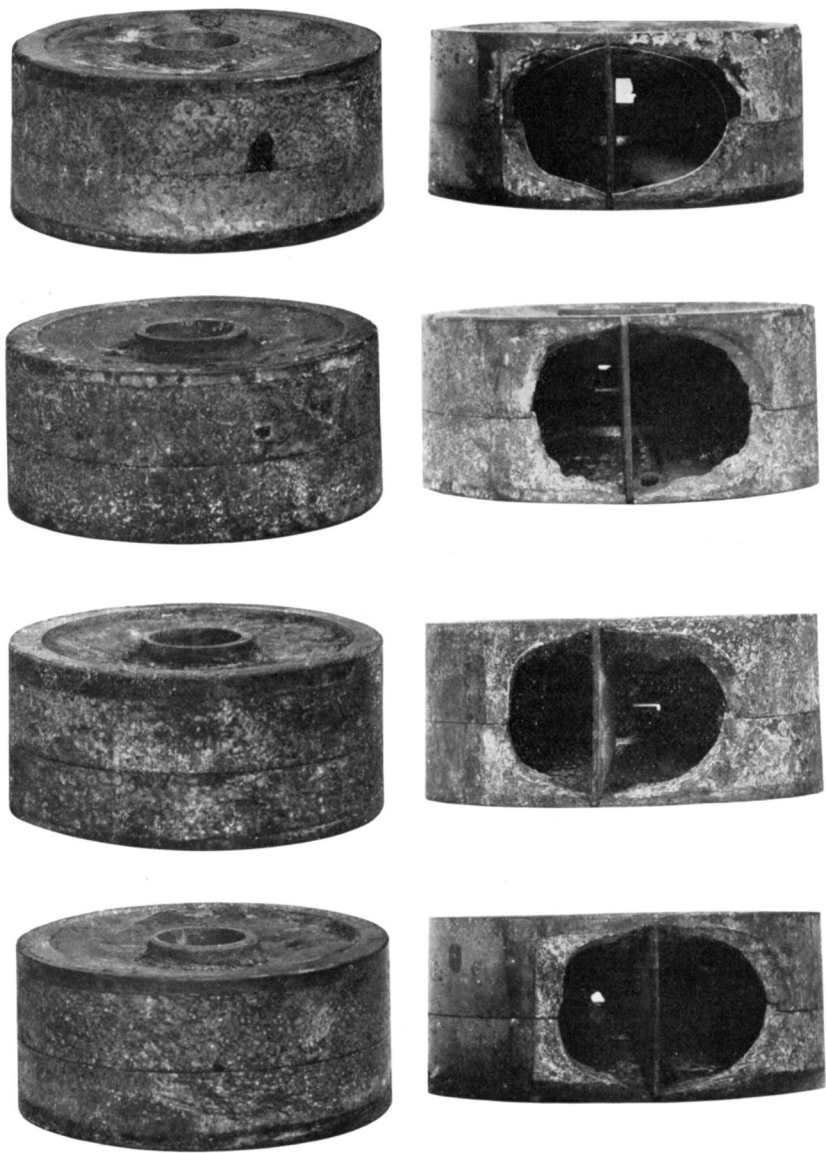
The analyses showed quite marked differences of composition of the bronze even between the two halves of the individual disc chambers, these differences being least in the analyses of the unaffected chamber. The analyses also seemed to show that the bronzes higher in zinc and lead were the most susceptible to the corrosion. Analyses of the water being used through these meters showed no chemical differences that would account for the difference in corrosion.

This case of corrosion of bronzes is not cited as an instance of the usual action of electrolysis, as no indication or instance could be found to indicate that any stray electric currents existed or were leaving the bronze at the affected portions. It does, however, seem to illustrate a somewhat similar decomposition of the metal that may be caused by local galvanic action due to differences in composition or treatment of the adjacent bronzes used.

APPEARANCE OF CORRODED DISC CHAMBERS
